THE WEYMEDE ESTATE BYFLEET

TREE SURVEY REPORT AND SCHEDULE

WEYMEDE RESIDENTS SOCIETY LTD

Written By:	R. Anderson
Checked By:	A Bigg
Date:	29/01/2021
Revision:	
Ref:	PRI21429trA

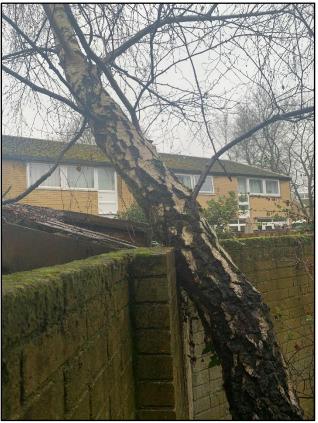
Photo of tree T4.5

- 4.1. Full recommendations can be found within the tree survey schedule.
- 4.2. Silver birch tree T4.5 is growing in contact with the garden boundary wall of number 1 and if not removed in the near future is likely to start damaging the wall.
